## The Post-Tensioning Association; Promoting Perfect Post-Tensioning

## Post-Formed Holes Through Post-Tensioned Slabs

This is a guide for Engineers, Contractors and Building Owners to help them safely locate and cut penetrations through post-tensioned slabs, after the slab has been constructed. Both bonded and unbonded PT systems are considered. This guide is applicable to PT flat slabs, PT beams and PT band beam slabs.

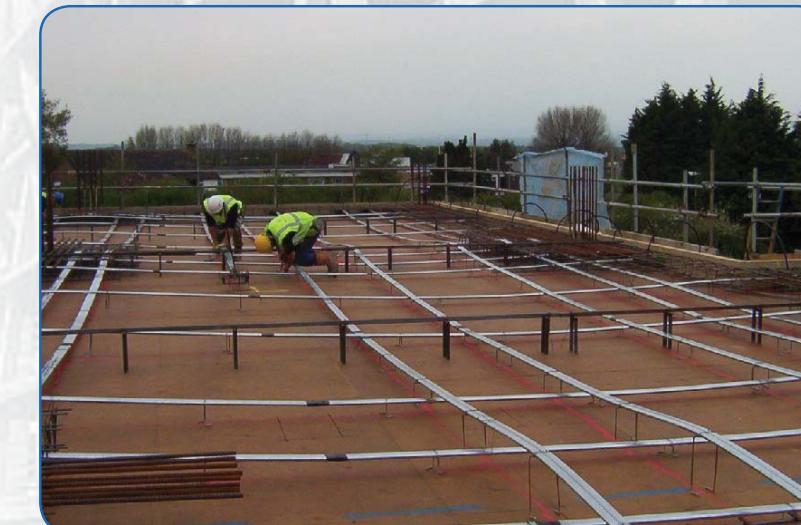
Fig 1 – decking painted to indicate tendon position

Post-tensioning strands are made from hard steel so it is difficult to damage them with a Tungsten Carbide (Masonry) drill bit if care is taken. However, a diamond core can quite easily cause significant damage. Services are often suspended from the soffit of the slab using post-drilled fixings and, if there are a lot of fixings to be installed such as for hospitals or plant rooms, consideration should be given to marking the soffit to show the tendon positions. This can be done by painting the deck prior to concreting – the paint transfers to the concrete soffit upon striking, ref Fig 1, or by using support chairs with coloured feet, ref Fig 2.

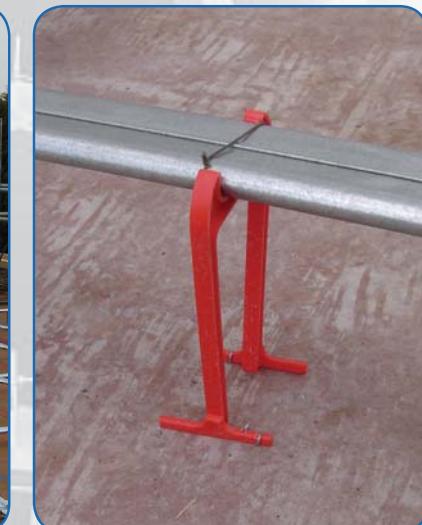
Fig 2 – coloured chair
